| 2013 Honda N-ONE 660 G L Package | | OVERALL<br>R | |
| INSPECTOR REPORT | | | |

ORIGINAL JAPANESE AUCTION SHEET

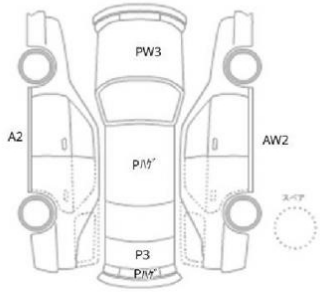
| Headliner and seats have stains and scuffs. Front inner cross support and lower support are damaged (XX). Body panel/bumper damage (BP). | | | |

| 検査記入欄<br>天張り、シートしみスレ<br>Fインナー・コササポート、ロアサポート××・BP | A キズ U ヘコみ・凹み B キズ・ヘコみ P 色あせ・剥け G ガラスキズ<br>W 補修跡 S サビ C 腐食 X 交換箇所 XX 交換車<br>登録No. 月 日 までに名義できる方<br>車体<br>番号 JG1-1036326<br>シリアル<br>No. | | | |
