| 2015 Honda N BOX N BOX 660 G L Package | | OVERALL | |
| INSPECTOR REPORT | | | |

ORIGINAL JAPANESE AUCTION SHEET

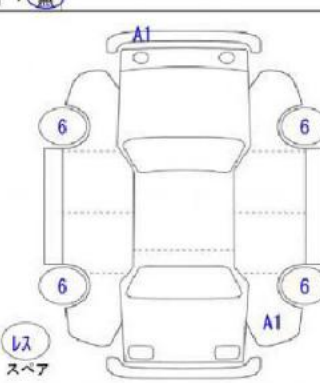
| | | EXTERIOR | INTERIOR |
| | | - | - |
| Exterior has minor scratches and dents. Underbody has rust. Equipped with studless tires. Interior has dirt/stains, scratches, (D) stains, burn marks, holes, scuffs, tears, and rips. Front glass has scratches, stone chips, cracks, and repair marks, requiring replacement. | | | |

| 外装 小A・小U | | | | | |
| 下廻り サビ | | | | | |
| スタッドレスタイヤ | | | | | |
| 室内 汚れ | | | | | |
| フロントガラス<br>キズ・飛石・ヒビ割・リペア跡・X要 | 内装<br>キズ・破れ・コゲ・穴・スレ・キレ・破れ | A-キズ E-エケボ U-凹み W-補修跡 S-サビ C-腐食 XX-交換済 | | | |
