| 2017 MAZDA Biente 2.0 20S SKYACTIV | | OVERALL | |
| INSPECTOR REPORT | | | |

ORIGINAL JAPANESE AUCTION SHEET

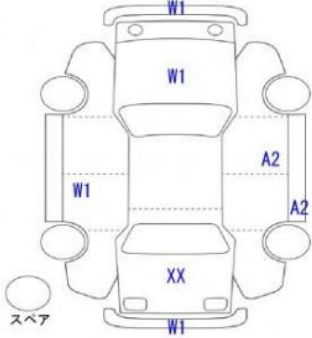
| | | EXTERIOR | INTERIOR |
| | | - | - |
| Slight distortion in rear floor. Front windshield: scratches, stone chips, cracks, repair marks, replacement required. Interior: scratches, dirt, burns, holes, scuffs, tears. | | | |

| | リアフロア歪み小 | 新車保証書<br>有・無 | 後日品 |
| フロントガラス<br>内装 | キズ・飛石・ヒビ割・リペア跡・X要<br>キズ・汚レ・コゲ・穴・スレ・キレ・破レ | A-キズ E-エクゴ U-凹み W-補修跡 S-サビ C-腐食 XX-交換済 | |
