| 2025 MAZDA CX-3 1.5 15S Vivid Monotone | | OVERALL | |
| INSPECTOR REPORT | | | |

ORIGINAL JAPANESE AUCTION SHEET

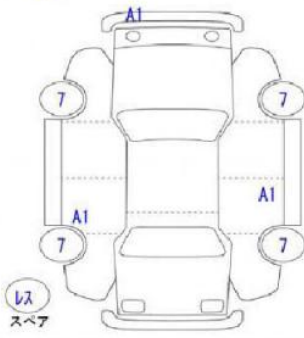
| 外装 小A・小U<br>左Rドア外し跡 | | 新車保証書 後日品<br>有・無 | |
| フロントガラス<br>内装 | キズ・飛石・ヒビ割・リペア跡・X要<br>キズ・汚レ・コゲ・穴・スレ・キレ・破レ | | |
| 車台番号<br>登録番号 | 849500<br>湘南 302 な 1492 | A-キズ E-エウボ U-凹み W-補修跡 S-サビ C-腐食 XX-交換済 | |
