2005 Honda Integra 3HB Type S

INSPECTOR REPORT

グー鑑定 コンディションチェックシート D24126F1501

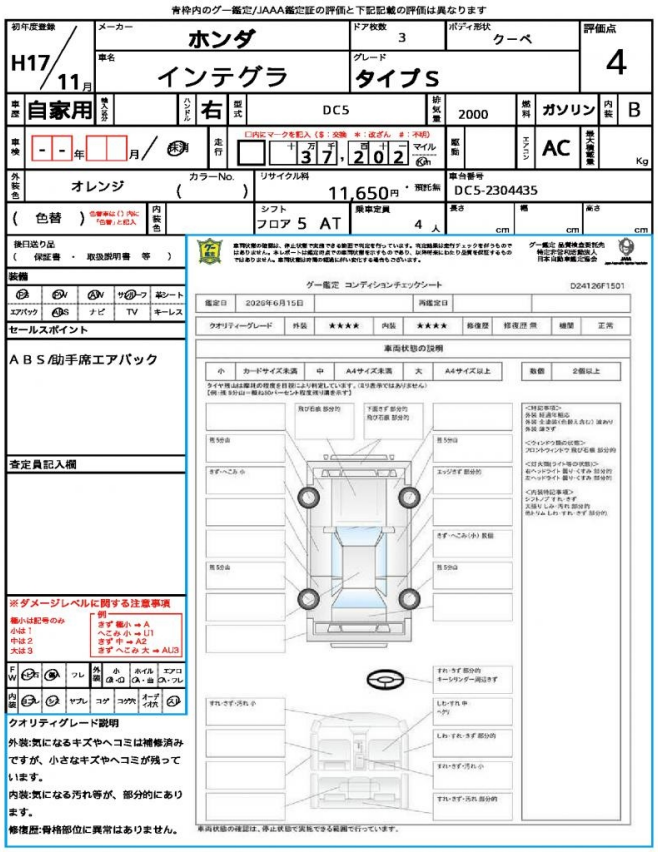
ORIGINAL JAPANESE AUCTION SHEET

Exterior: Noticeable scratches and dents have been repaired, but small scratches and dents remain. Interior: Some noticeable stains are present. Repair history: No abnormalities in the structural components.

外装:気になるキズやヘコミは補修済みですが、小さなキズやヘコミが残っています。

内装:気になる汚れ等が、部分的にあります。

修復歴:骨格部位に異常はありません。

<ウィンドウ類の状態>
フロントウインドウ 飛び石傷 部分的

<灯火類(ライト等の状態)>
右ヘッドライト 曇り・くすみ 部分的
左ヘッドライト 曇り・くすみ 部分的

<内装特記事項>
シート/ダッシュ 汚れ、きず
太陽モ しみ・汚れ 部分的
他パネル しわ・すれ・きず 部分的
