2010 BMW_Mini BMW Mini Convertible Cooper Convertible

INSPECTOR REPORT

グー鑑定 コンディションチェックシート R30426D0709

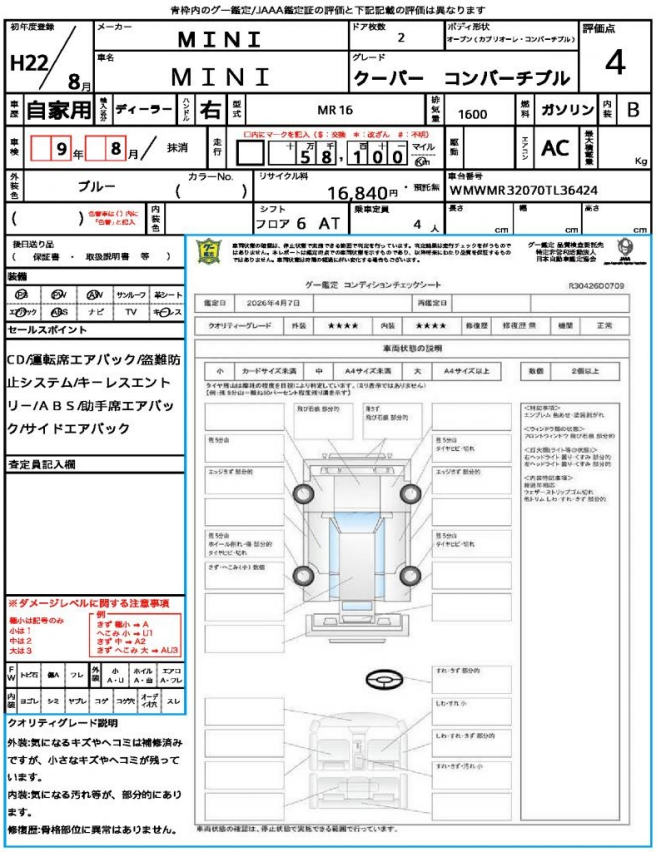
ORIGINAL JAPANESE AUCTION SHEET

Exterior: Minor scratches and dents have been repaired, but small scratches and dents remain. Interior: There are some noticeable stains, but only in parts. Repair history: No abnormalities in the frame.

外装:気になるキズやヘコミは補修済みですが、小さなキズやヘコミが残っています。

内装:気になる汚れ等が、部分的にあります。

修復歴:骨格部位に異常はありません。
