2014 Nissan Elgrand Rider

INSPECTOR REPORT

ORIGINAL JAPANESE AUCTION SHEET

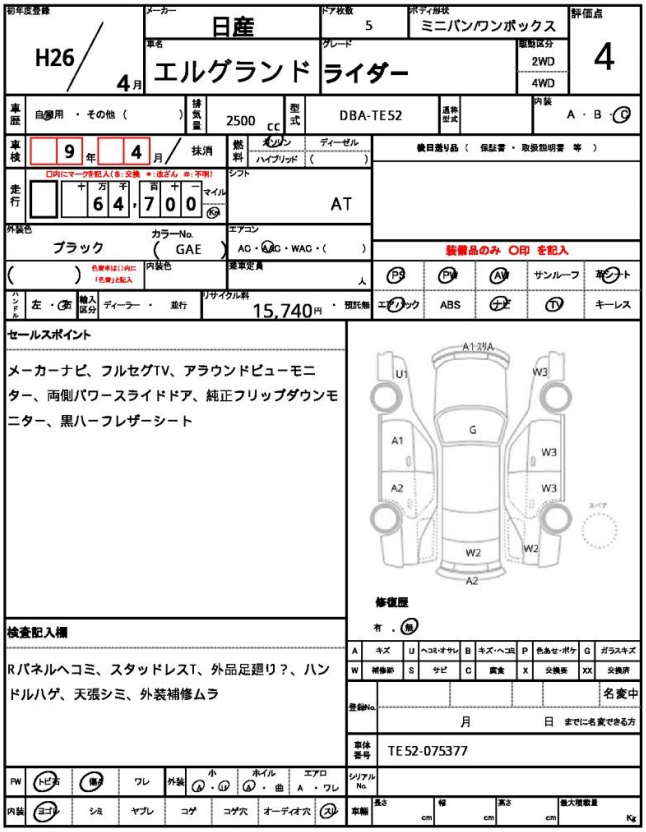
Rear panel dent, studless tires, aftermarket suspension (unconfirmed), worn steering wheel, headliner stains, uneven exterior repair.

検査記入欄
Rパネルヘコミ、スタッドレスT、外品足廻り？、ハンドルハゲ、天張シミ、外装補修ムラ
