# 2016 BMW_Mini BMW Mini Clubman Cooper D Clubman

ORIGINAL JAPANESE AUCTION SHEET

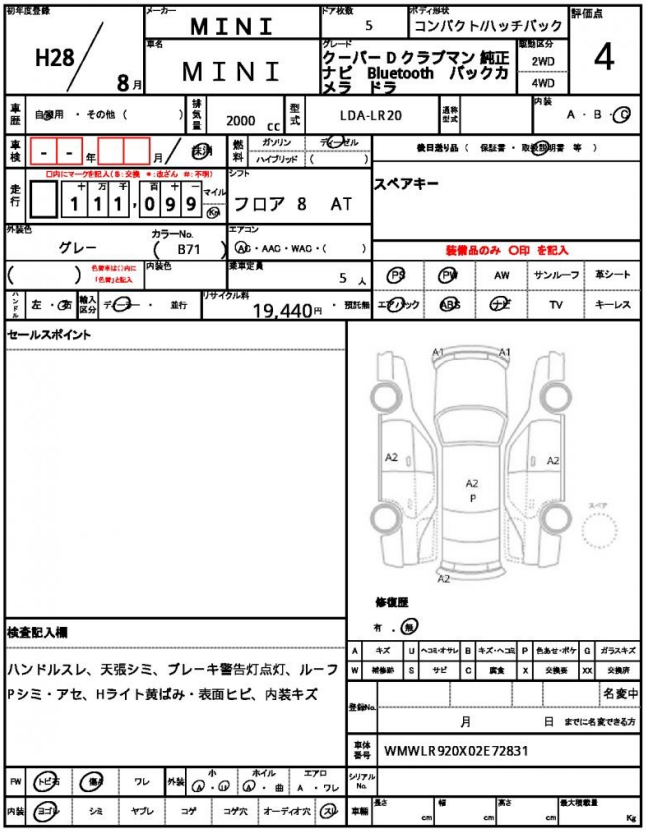
Steering wheel wear, headliner stains, brake warning light illuminated, roof paint stains/fading, headlights yellowing, surface cracks, interior scratches.
