2024 VOLVO VOLVOV60CrossCountry Cross Country Ultimate B5 AWD

INSPECTOR REPORT

ORIGINAL JAPANESE AUCTION SHEET

グー鑑定 コンディションチェックシート K32325J0603

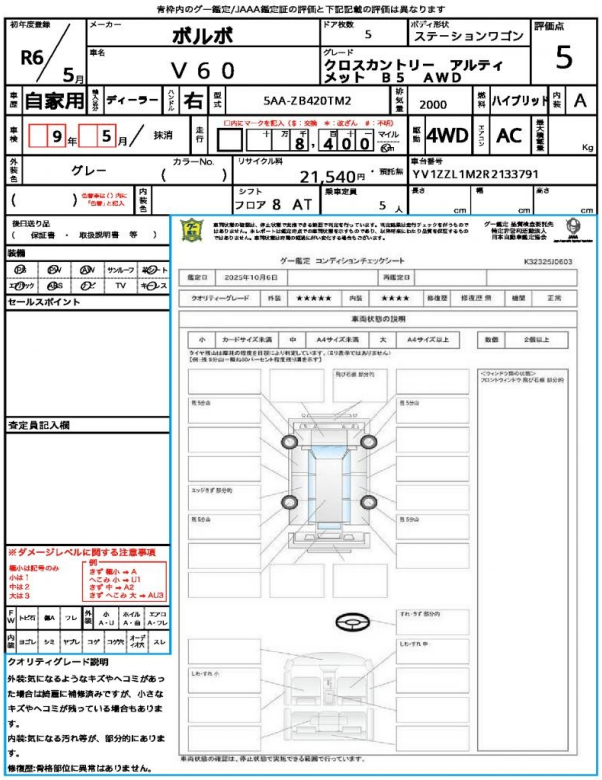
Exterior: Noticeable scratches and dents have been neatly repaired, though minor ones may still be present. Interior: Some noticeable stains are present in parts. Repair History: No abnormalities in the structural components.

外装:気になるようなキズやヘコミがあった場合は綺麗に補修済みですが、小さなキズやヘコミが残っている場合もあります。

内装:気になる汚れ等が、部分的にあります。

修復歴:骨格部位に異常はありません。

右 9分山	前 5分山	左 9分山	後 5分山

エッジきず 部位外	
右 9分山	左 9分山

すれ・きず 部位外

しわ・すれ 中

しわ・すれ 小
