# 1999 Mitsubishi Pajero 5D Long Exceed

## INSPECTOR REPORT

ORIGINAL JAPANESE AUCTION SHEET

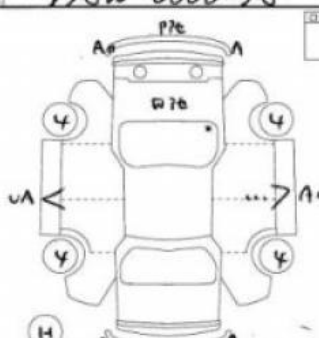
Steering wheel scuffed, headliner scuffed and dirty. Minor scuffs, rust, and many scratches are present. The 4WD lamp is not illuminating. There is paint fade on the bonnet underside and paint rust on the undercarriage. All four tires (front and rear) are worn (double P) and cracked. A snorkel is installed, but the rear wiper is missing, the rear garnish paint is damaged, and the rear gate inner trim cover is missing.
